The Högakusten Suspension Bridge - Corrosion Protection of Main Cables and Major Components

**Swedish Road
Administration:**

COWI:

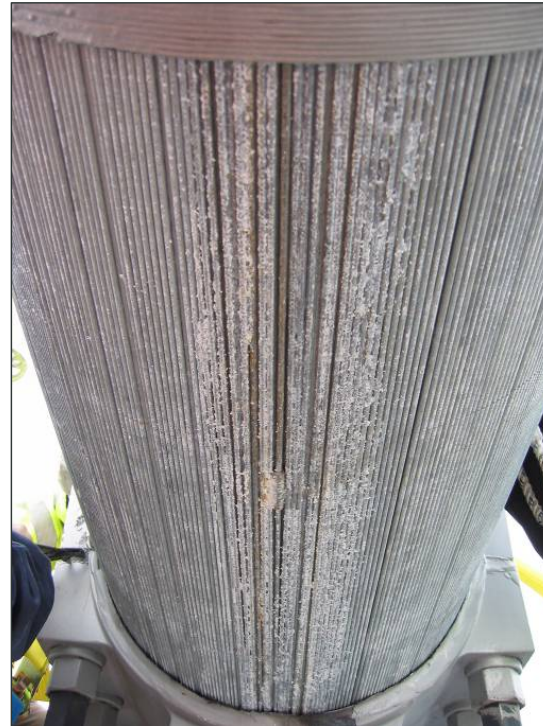
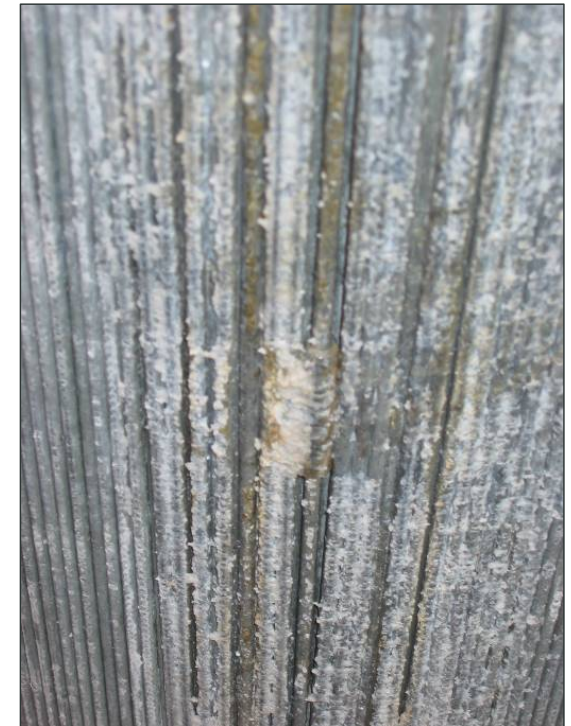
Inspection 2004

- Zinc paste omitted under construction
- Original protection defective
- Large amounts of water flowing in cables
- Forecast 2003 - depleted zinc within 10 years

- Depleted zinc on bottom wires
- Spots of ferrous corrosion
- Just 6 years after completion

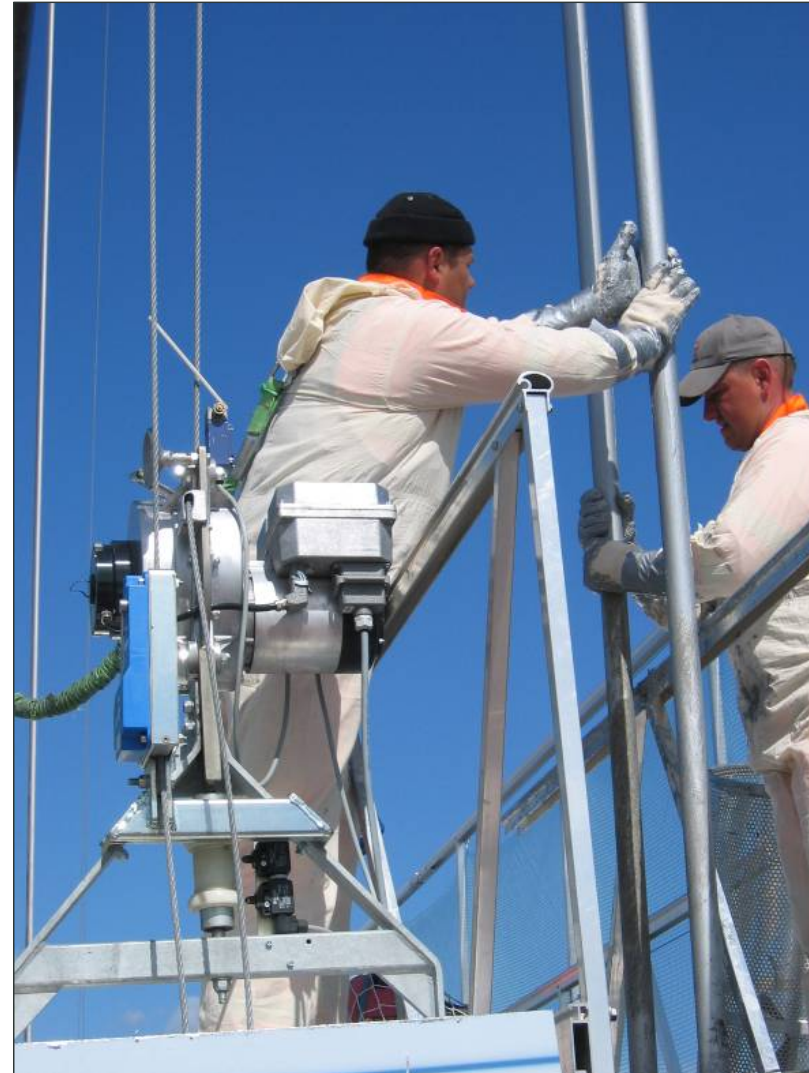
Suspender cables

- Total of 18 km cable
- Feared that filler was leaking through the paint
- Original paint not as recorded
- Actually Metalcoat from Bridon
- Insufficient thickness and contamination in grooves
- Cleaned with solvent and paint with sufficient thickness

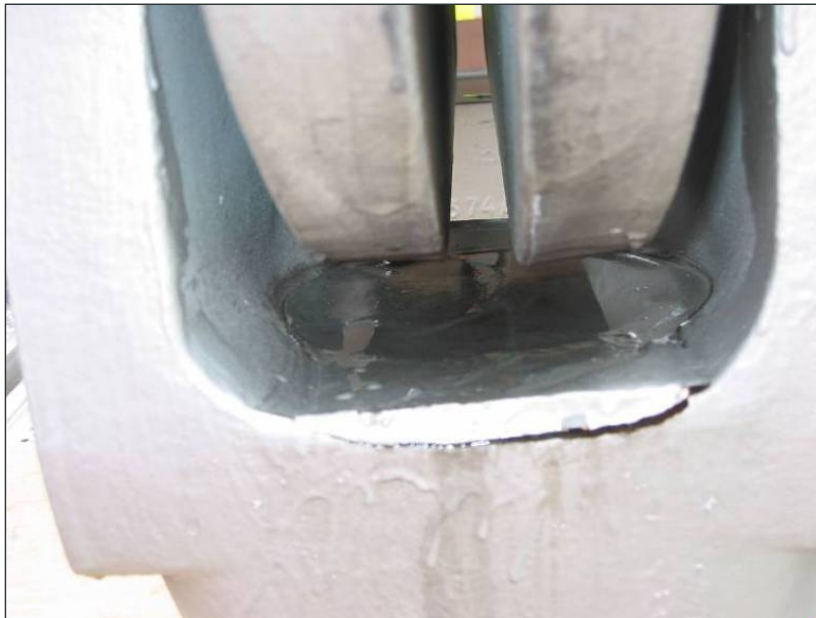
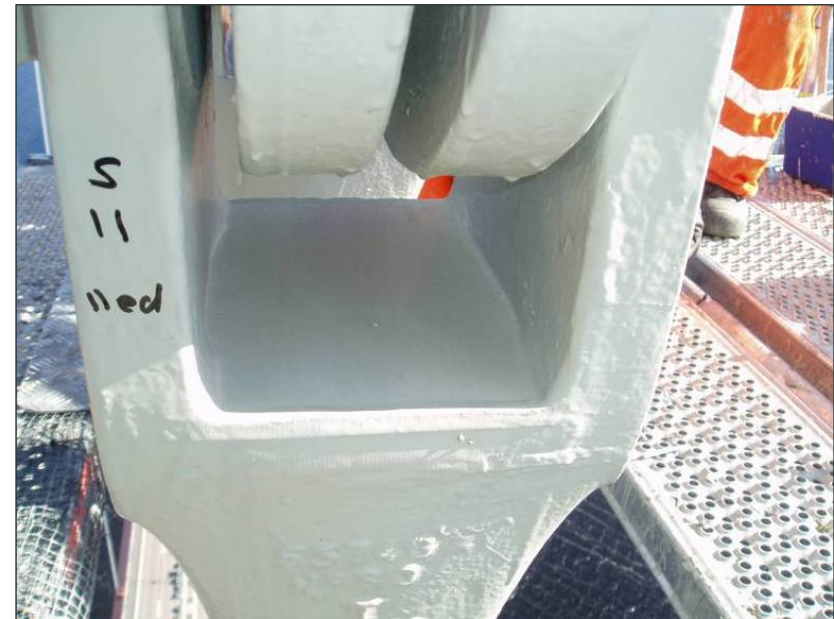
Upper sockets

- Sealing of upper sockets defective
- Material was brittle, lacked adhesion and cracked along edge
- Concave surface - water accumulation
- New solution with flexible material and plane surface

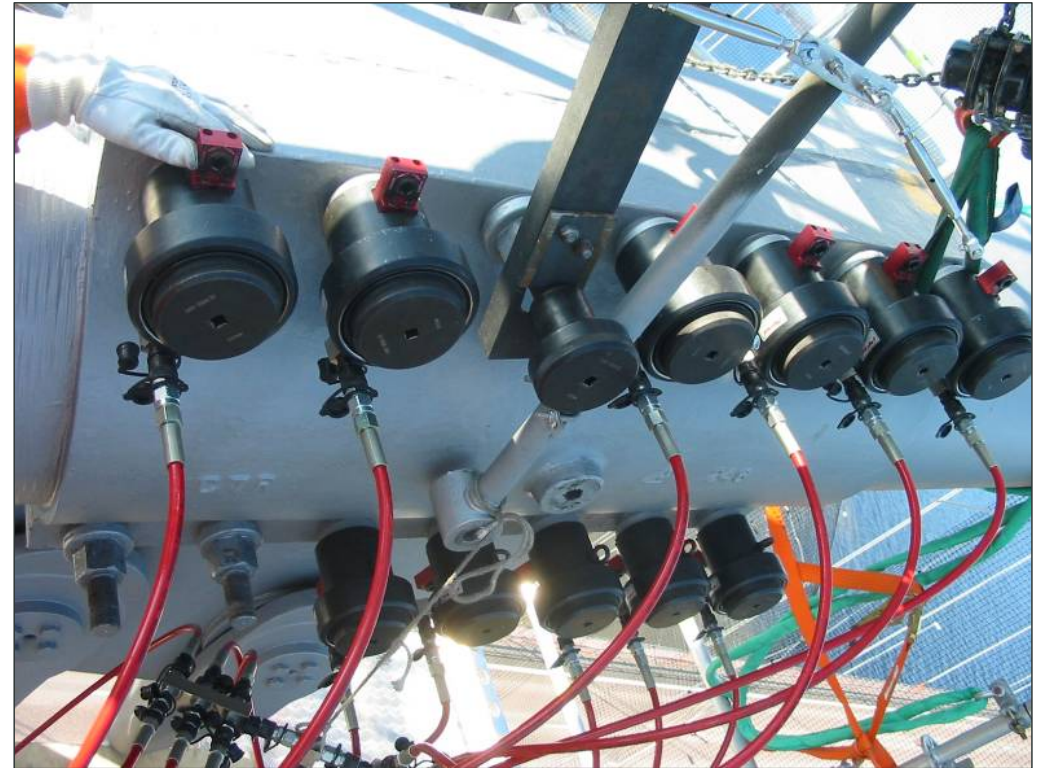
Cable band bolts

- Spot check of tension included
- Option for re-tensioning
- Reduction of forces generally app. 30% from 770 kN to 550 kN
- To fulfill design requirements bolts in 100 out of 164 cables band were re-tensioned

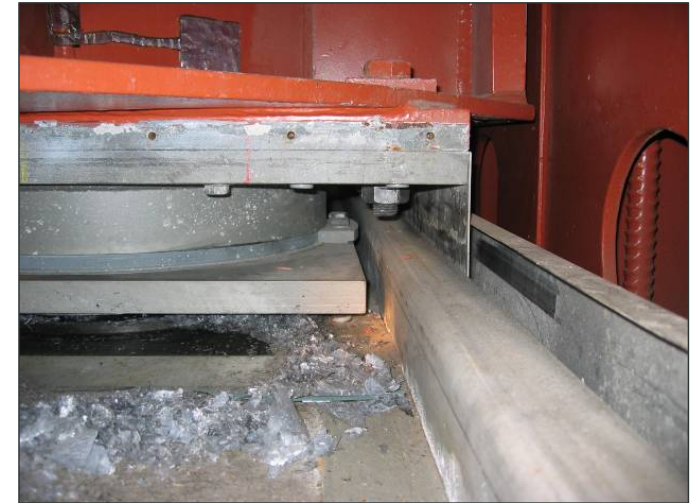
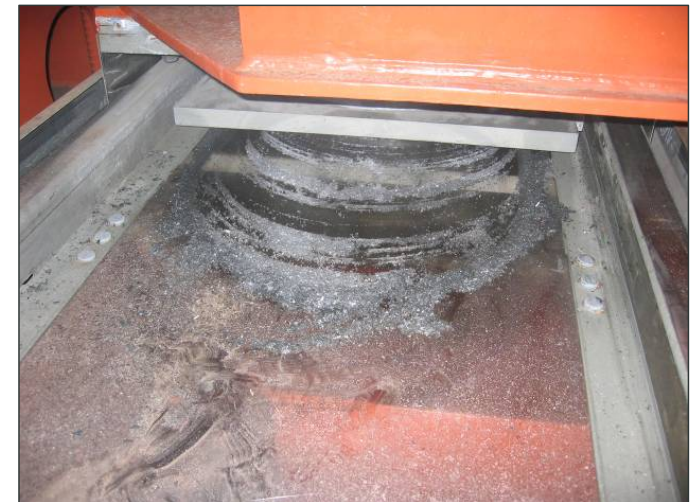
End bearings

- The PTFE sliding surface of the end bearings was subject to excessive wear
- Investigations were carried to determine if vertical loads were larger than expected
- Vertical loads were within the expected range
- Causes determined to be low operation temperature (-20°C) and excessive friction
- Solution in 2007 - new sliding surface of MSM from Maurer
- Advantages of MSM
 - Less wear at low temperature
 - Larger load capacity
 - Less friction
 - Expected movement capacity of 50 km contra 10 km for PTFE
