The Högakusten Suspension Bridge - Corrosion Protection of Main Cables and Major Components

**Swedish Road
Administration:**

COWI:

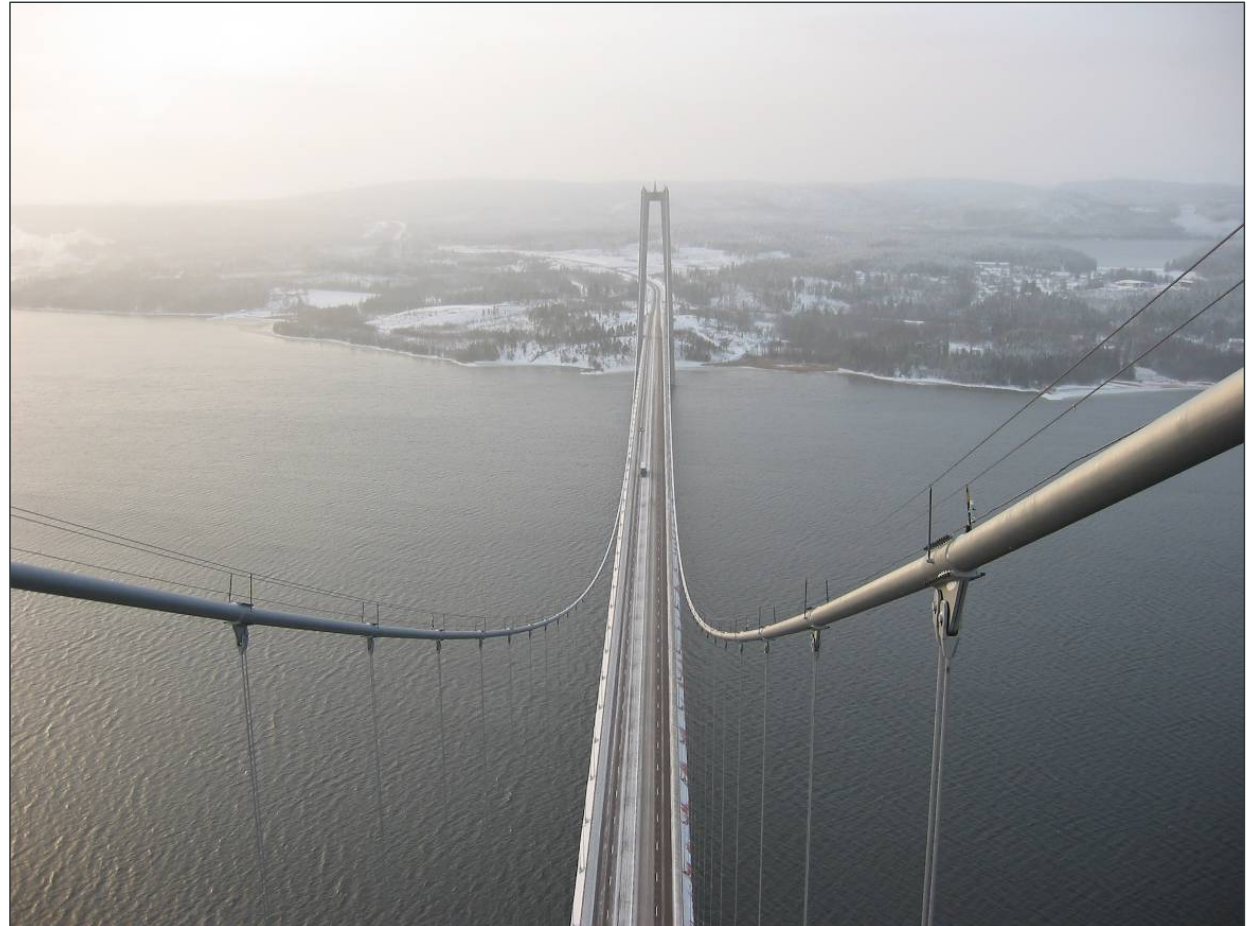
Main cable condition

- Zinc paste omitted under construction
- Original protection defective
- Large amounts of water flowing in cables
- Forecast 2003 - depleted zinc within 10 years
